Survey and Research Report on the Walters Barber Shop

1. Name and location of the property: The property known as the Walters Barber Shop is located at 112-114 South Main Street, Huntersville, N.C.

Prepared by Stewart Gray
March, 2016

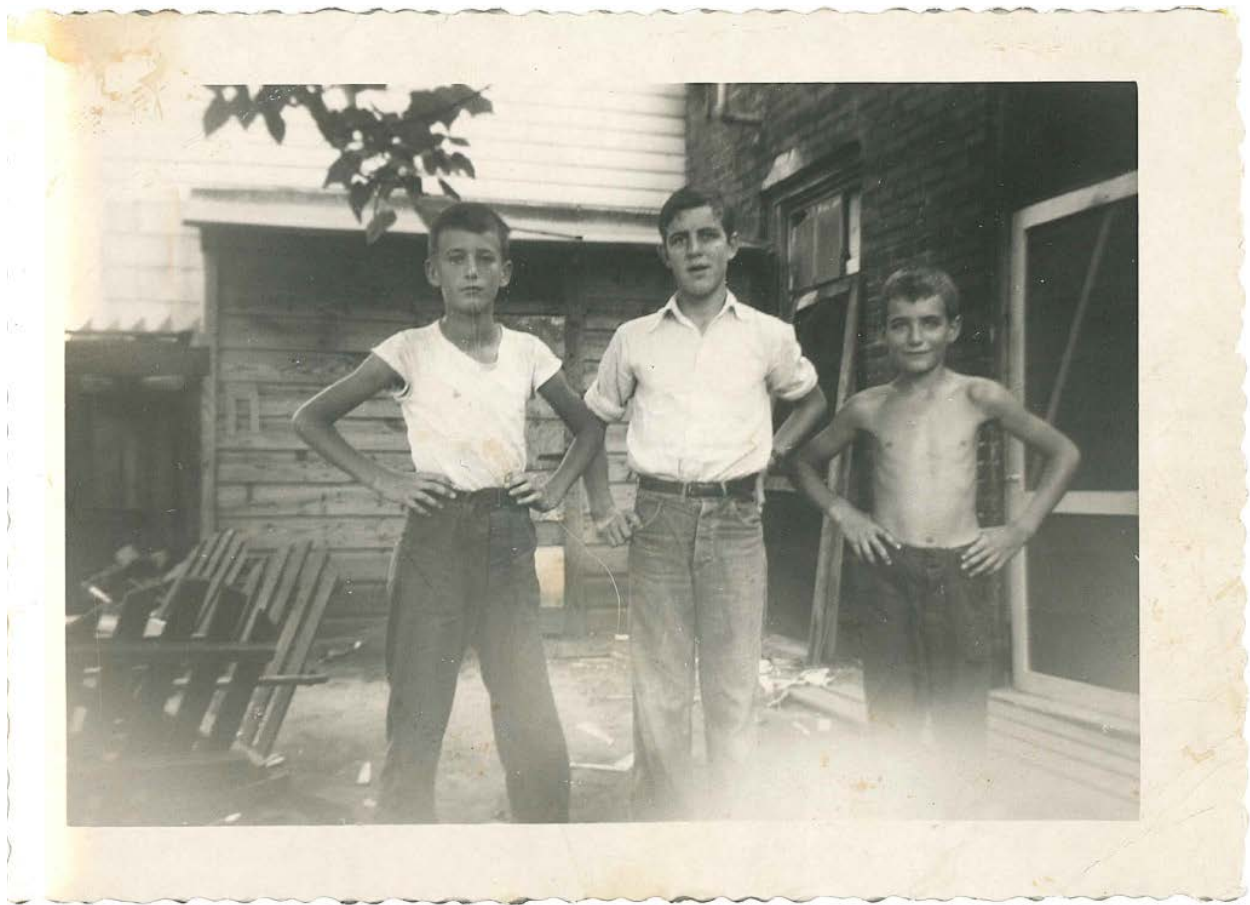
John and Paul Walters (unknown friend center) around 1946, at the rear of the Walters Barber Shop. The door to the right led to their apartment. The door on the left led to the barber shop.

The rear of the building is four bays wide. It is sheltered by a non-original hipped porch supported by metal posts. The rear wall is laid in American bond, and is covered with stucco. The fenestration is symmetrical. The center two bays contain doors. The original door frames are extant, but now contain modern replacement doors. The doors are topped with single-light-sash transoms, now covered with plywood. The outer bays are window openings, now infilled with framing and plywood panels and contain air conditioner units.

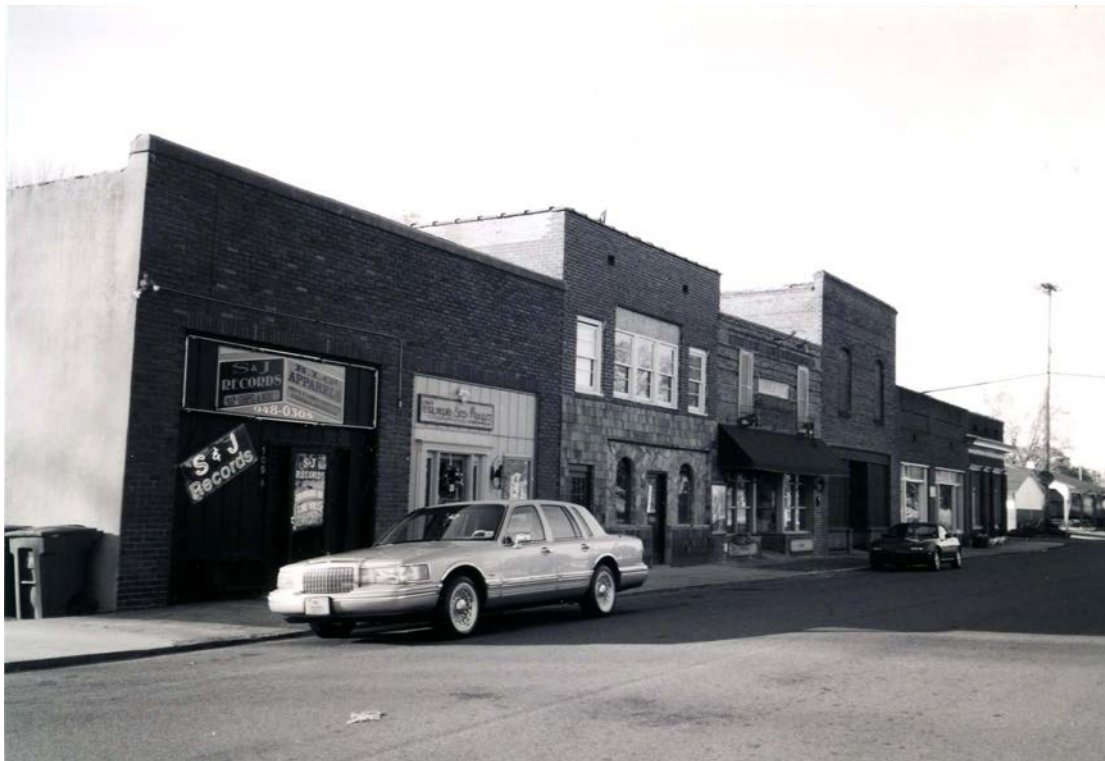
Walters Barber Shop, ca. 2000

Cecil Bradford bought the property from Annie Hill in 1980.¹¹ The two commercial spaces were subdivided into smaller commercial spaces, and the original storefronts with recessed entrances were rebuilt with flush frame walls. The final tenants included a beauty shop and a record store. The building has been vacant since around 2010.

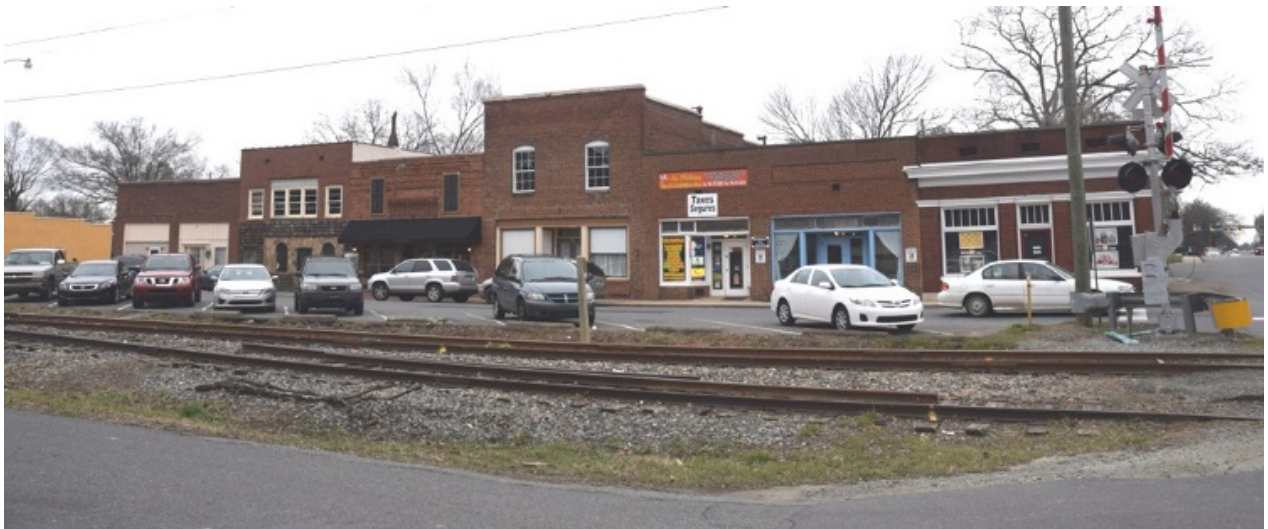
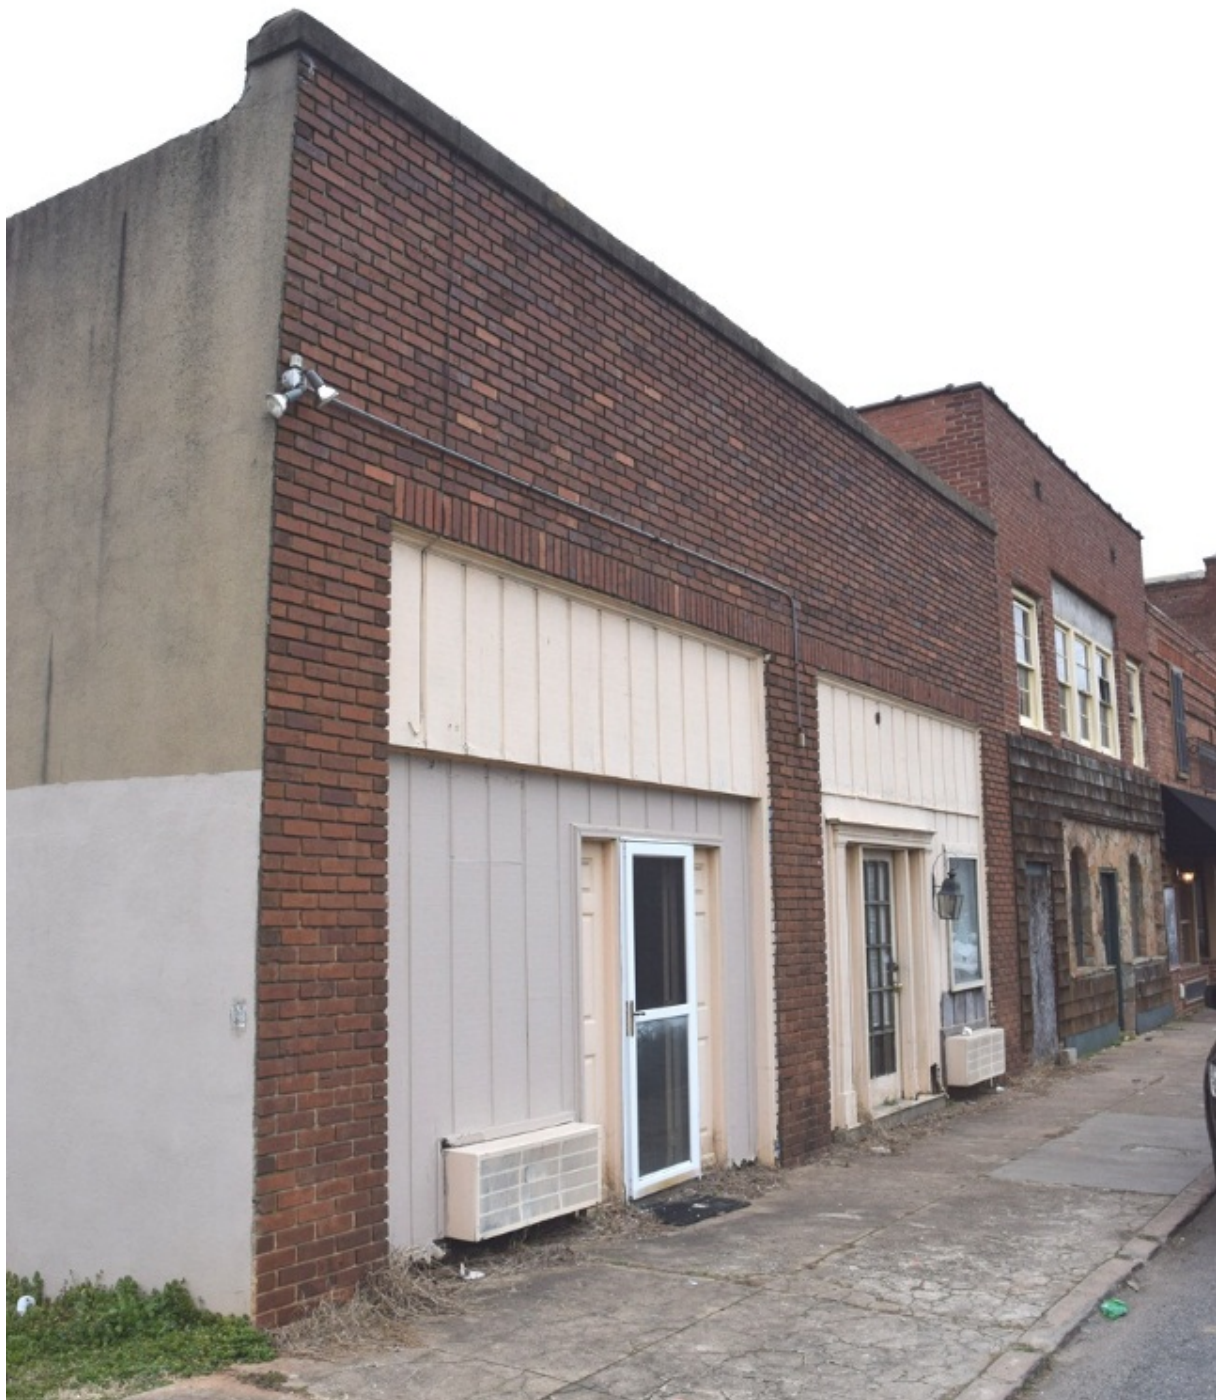
The façade features two storefront openings. Each opening originally featured a recessed door centered between large plate-glass windows that rested on brick knee walls, and were topped with a large transom composed of six roughly square sash.

The openings have retained the outer members of the plate-glass window frames, the transom window frames, and portions of the brick knee walls. The transom window sash are in storage. Currently the openings are filled with framing covered with plywood panels and pierced by replacement doors. The façade features a veneer of nicely finished brick laid in running bond, over the structural brick wall which is laid in American bond. The two bays are each topped with a soldier course. The front wall is topped with a parapet. The parapet is topped with a parged corbelled brick cap.

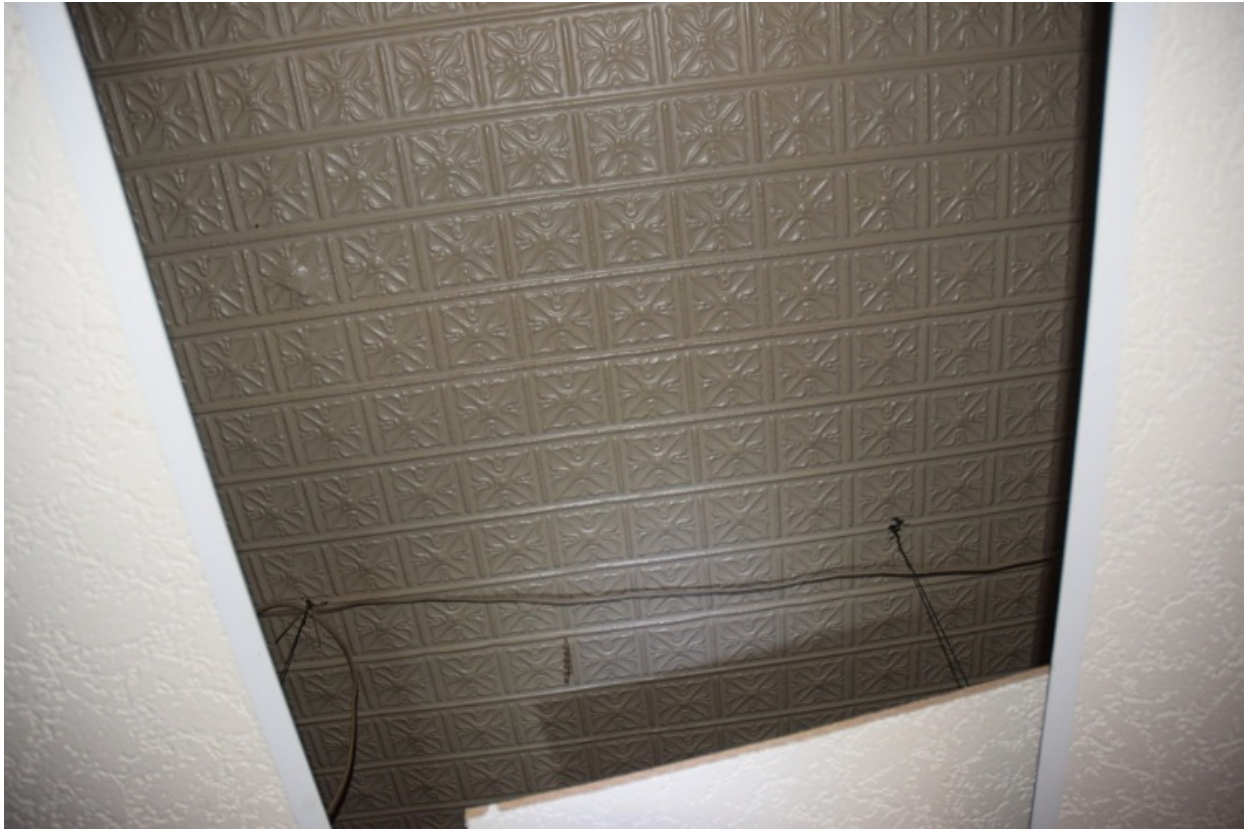
The interior of the building is divided equally by an original frame wall that runs from the front to the rear wall. A single doorway in the interior wall in the rear section of the building connects the two spaces. The interior space was divided late in the 20th century into four roughly equally sized commercial spaces. Four small bathrooms were added, each serving one of the commercial spaces, to the middle of the building, separating the front from the rear sections. The original concrete floor is extant in the two front sections, but a new raised (6 inches) concrete floor was added in the rear of the building, probably to accommodate the plumbing for the bathrooms.

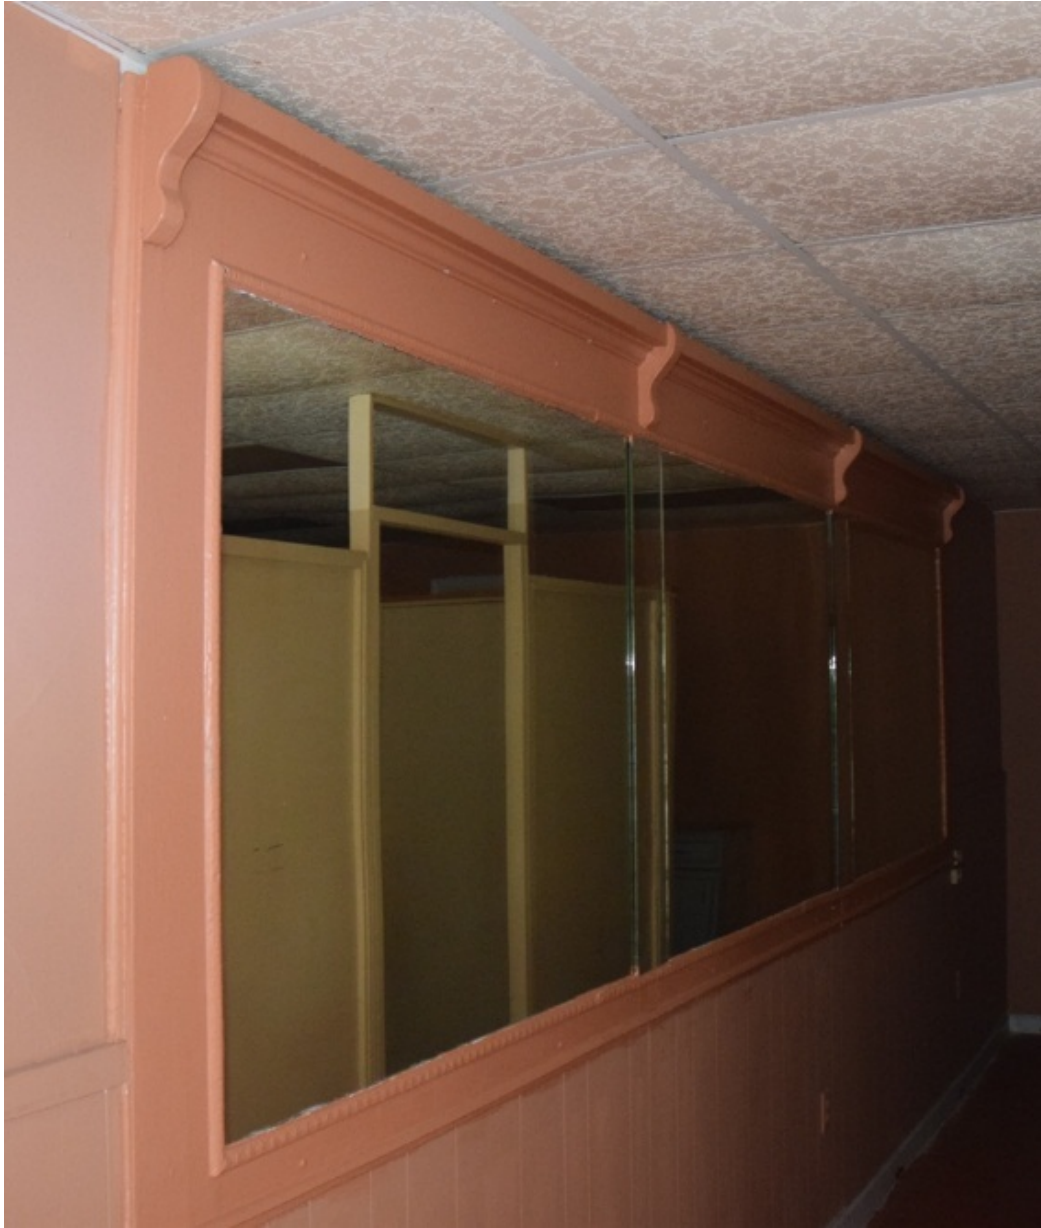
The building features a pressed tin ceiling throughout. The ceiling is now obscured by a drop ceiling. The exterior walls are plastered. Some of the original plaster of the interior frame wall has been replaced with wallboard. Simple moulded trim around the doors, and ceiling has survived. An original large mirror in the barber shop has survived. It features decorative moulding around the glass, and brackets that once supported a shelf.
